## NACC Case Study:

# COMCAST TECHNOLOGY CENTER

### Philadelphia, PA

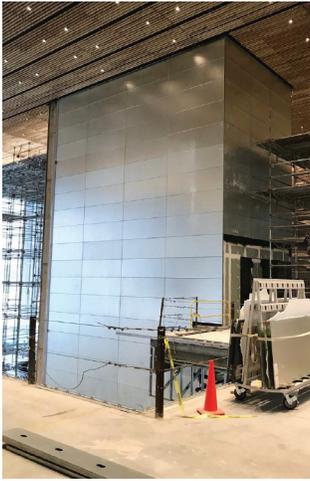
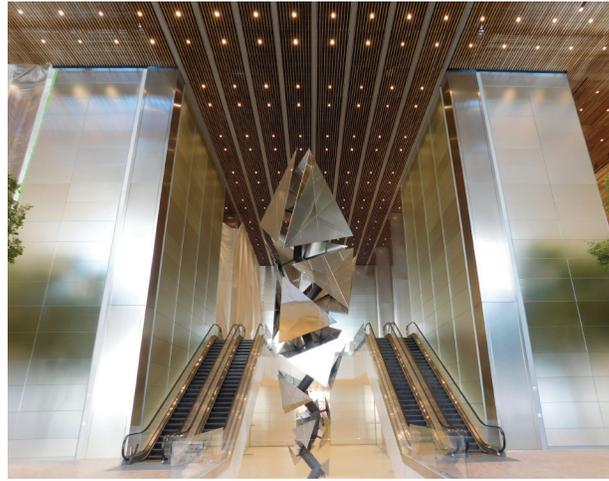
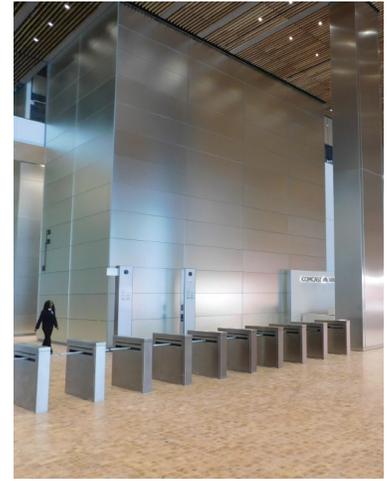
*Left: glass installation (image courtesy Eureka); center and right: completed lobby*

The Comcast tower’s five-story glass-enclosed atrium lobby contains a winter garden with 30-foot-tall tropical trees. The lobby podium incorporates 2,700 nine-by-three-foot decorative glass wall panels. Eureka Metal & Glass Services, Inc. performed the installation – and claims its NACC certification helped the team identify a manufacturing design limitation and find a solution. Eureka President Terry Webb explained that certification forced his team to look at every process and identify
